## **Massachusetts State Laboratory**

### **Improvements Study ST 02R**

#### **Inventory and Analysis**

Project Number DPH 0702 ST1

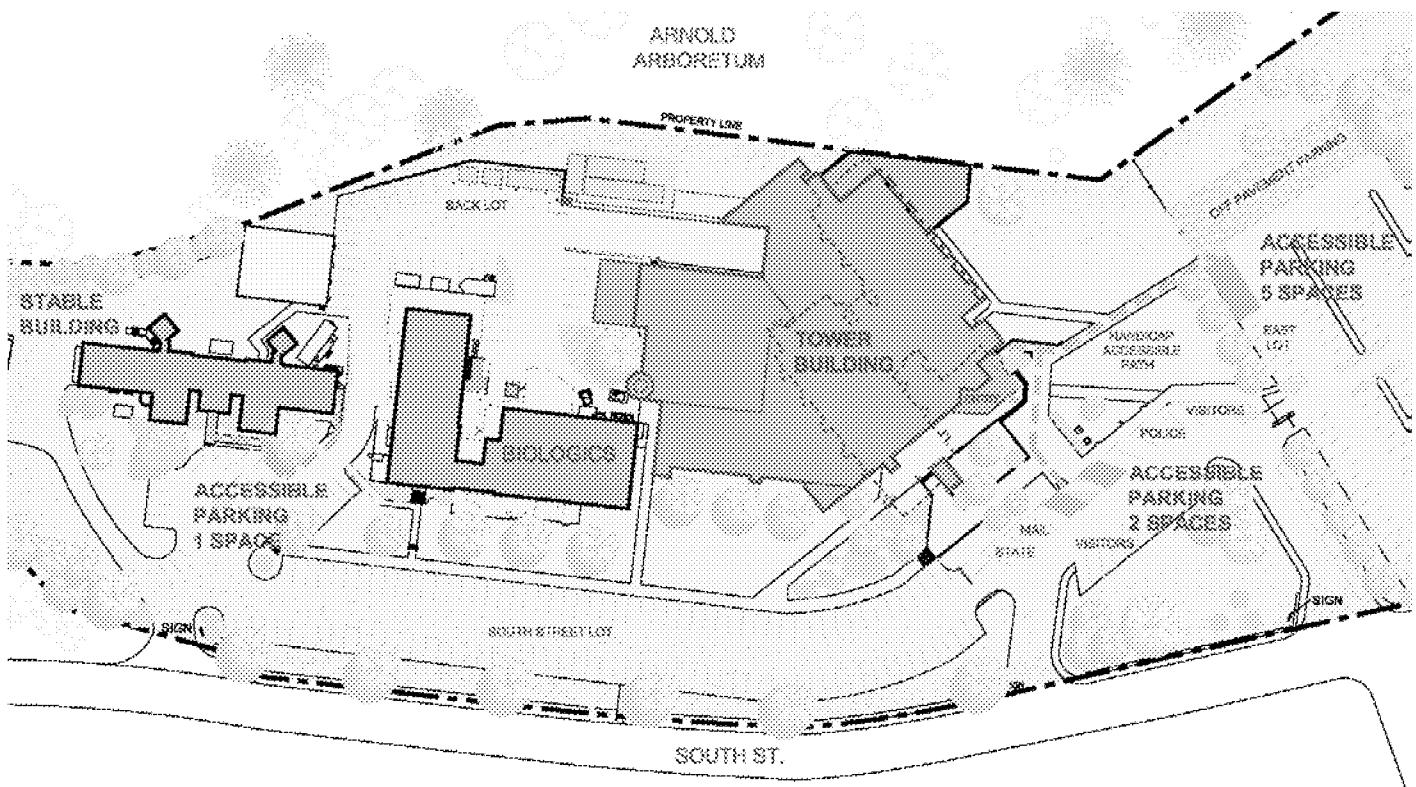
The sketch below illustrates the location of the current handicap spaces and accessible routes. The pavements along all accessible routes are degraded to varying degrees | it is likely that none of the routes are fully compliant. Deficiencies include:

- Worn or missing pavement markings;
- Lack of proper signage;
- Pedestrian paving and curb cuts which are in very poor condition and need of replacement.

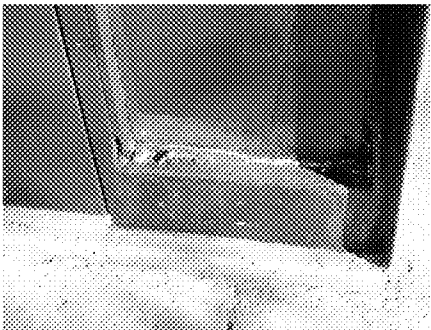
- Water infiltration above the window heads is prevalent on west wing.
- It is not known if sealants around the original steel window frames have been replaced.

- Some sealant repairs/applications have been made on the exterior mechanical exhaust towers.
- Water infiltration has been observed in all four egress stair wells.

- Water infiltration exists around the skylights at the Food and Drug wing.
- The windows are single glazed steel frame units.
- No subsurface water infiltration has been experienced, except for the basement electrical room, which was waterproofed in conjunction with the Emergency Electrical Project in 2010.

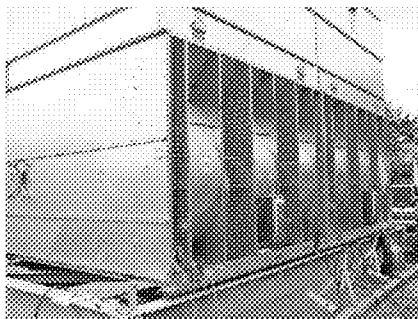
In the summer of 2010, the cooling system performance had degraded to the point where vital laboratory equipment had to be shut down due to rising temperatures within the building, in order to avoid health and safety issues for personnel working within these labs and damaging the equipment. This situation led to an Emergency HVAC Improvement project, which has been completed and provides:

Upon completion of the new supply and exhaust air handlers, it became apparent that the distribution ductwork is seriously degraded and in need of replacement, and may not allow the system to function at its capacity.

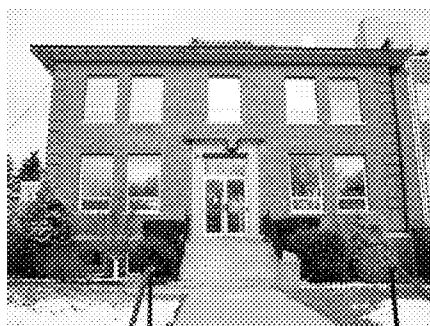
**Biologic Building Observations**

- Remedial roof repairs at membrane seams and flashings were accomplished on the east wing in the fall of 2007.
- Roof access bulkhead on north wing roof has previously been problematic – especially with melting slush, however this is not currently a problem.
- Light to moderate brick spalling. This is most severe on the east wing with some additional occurrences on portions of the north wing. The south and east elevations of the east wing seem to have a higher percentage of spalled brick, while the north elevations have somewhat less. The north wing exhibits some areas of spalled brick but not as predominate as the east wing. As a general observation, approximately 25% to 30% of the total brick wall surface area for the

- Brick mortar joints are deteriorating. It was suggested that water infiltration on the interior horsehair plaster walls of the southwest portion of the building has been observed with a red tint which may be from the brick. In addition, there is mortar joint deterioration predominately on the east and north wings of the building. The more severe areas can be observed on the south and east elevations of the east wing, and the east and north elevations of the north wing along with portions of the west elevation, north wing. As a general observation, approximately 40% to 45% of the total mortar joint wall surface area for the entire building could be affected.

- No subsurface water infiltration is exhibited in basement areas.
- Peeling ceiling and wall paint are likely evidence of water infiltration damage.
- Water infiltration at the interior window jambs is an ongoing problem at the north wing.

- There are portions of the upper wall areas where the corners of the building are deteriorating to the point of an impending wall failure. This is observed at the north wing, northeast and northwest corners near the parapet, and the east wing, southeast corner near the parapet.

- Rusting relieving angles at window and door heads.
- Sealant deterioration at window and door relieving angles.
- Windows are aluminum frame with insulating glass.

- Extensive damage to sheetrock jambs at window sills of the north wing.
- Cracking plaster at upper floor wall surfaces, north wing.
- Wood fascia board at roof will not hold paint and paint is peeling at underside of the roof overhang.

- Mortar or sealant missing at precast concrete belt course joints.

- Brick joint cracking at corners of building above foundation wall.
- Exterior wood door frame deterioration, paint peeling and sealant failure.
- The slate roof exhibits several areas of broken slates, with metal hip flashing in need of repair.

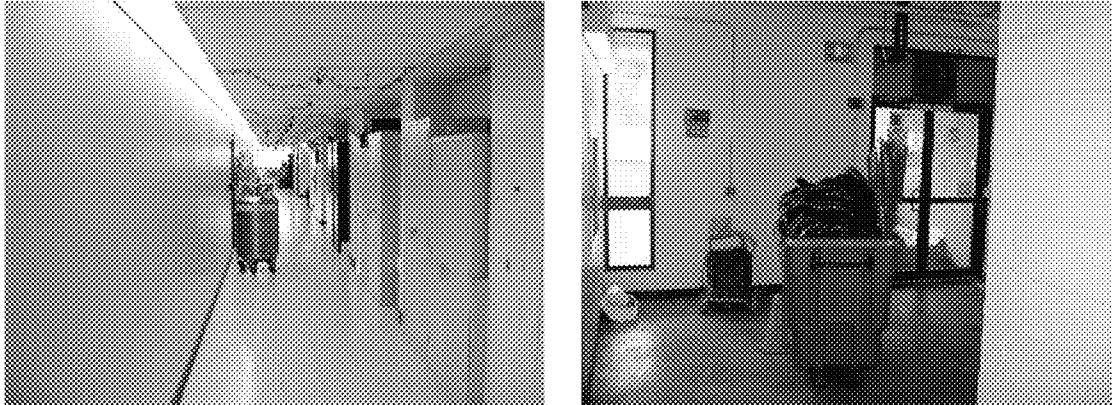
10. Combustible storage and wall hangings were observed throughout exit access corridors. In addition trash barrels and miscellaneous storage was also observed in a majority of the stair enclosures. These materials should be relocated out of means of egress components.

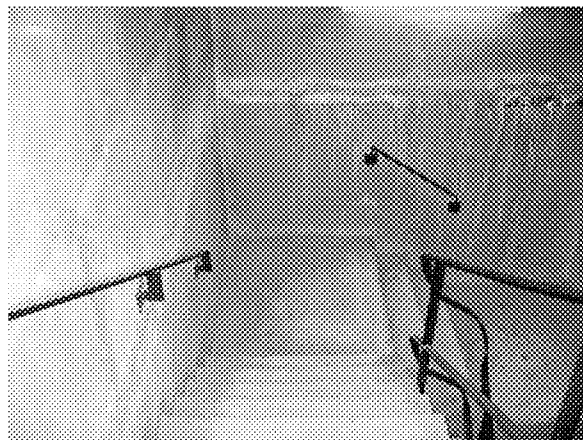
12. Existing guards located within existing stairs are approximately 36 inches in height with 24 inch open guards. Guards should be at least 42 inches in height measured vertically above the leading edge of the tread or adjacent walking surface (MSBC 1013.2). Open guards should not have openings which allow passage of a sphere 4-inches in diameter from the walking surface to the required guard height (MSBC 1013.3). From a height of 36 to 42 inches, guards should not have openings which allow passage of a sphere 4-3/8 inches in diameter (Exception 1). The triangular openings at the open sides of a stair, formed by the riser, tread and bottom rail should not allow passage of a sphere 6-inches in diameter (Exception 2).
